AFWAL-TR-89-2012

IMPROVED FATIGUE LIFE BEARING DEVELOPMENT

June 1989

Final Report for Period September 1984 - December 1988

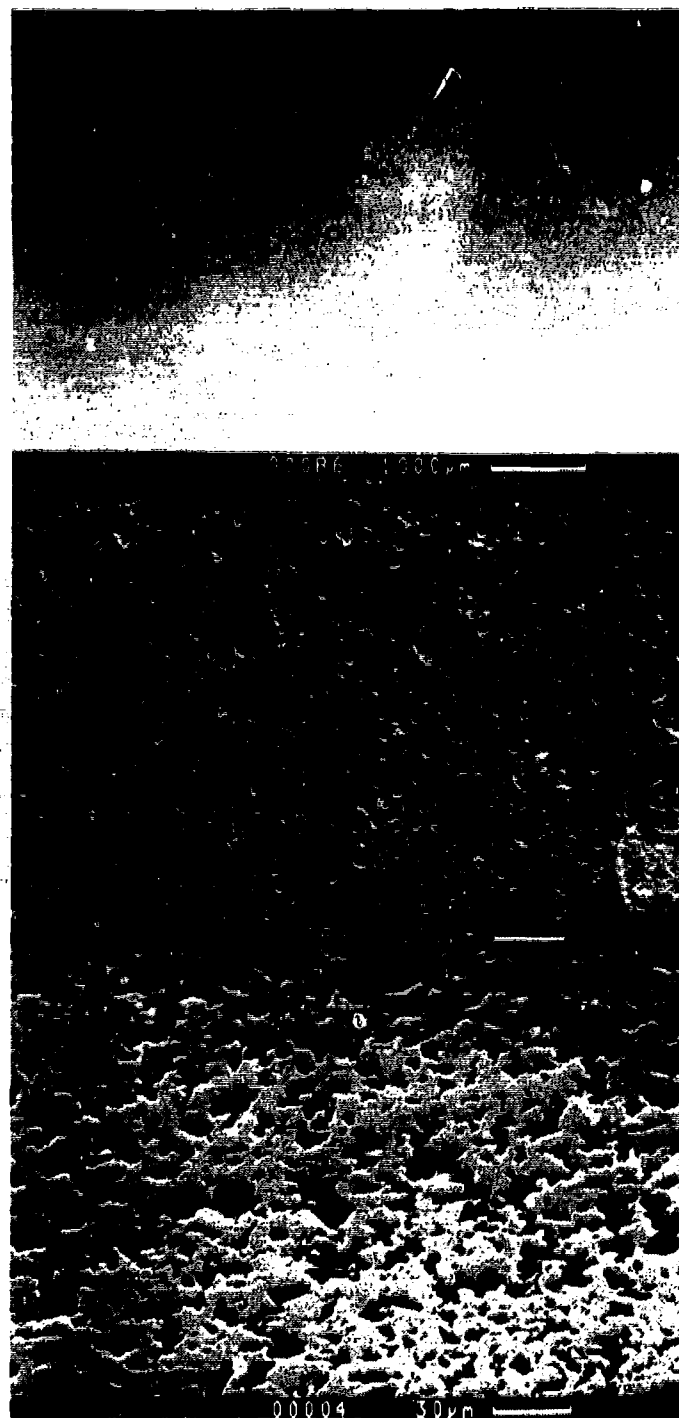
Figure 7 shows typical surface distress observed as a consequence of skidding. The surface appears frosty at low magnifications, but micropitting is evident at higher magnifications. This type of surface distress is typical of

Figure 7. Surface Damage Resulting from Ball Skidding. *This is a typical "orange peel" appearance and will usually propagate to more extensive micropitting and spalling.*

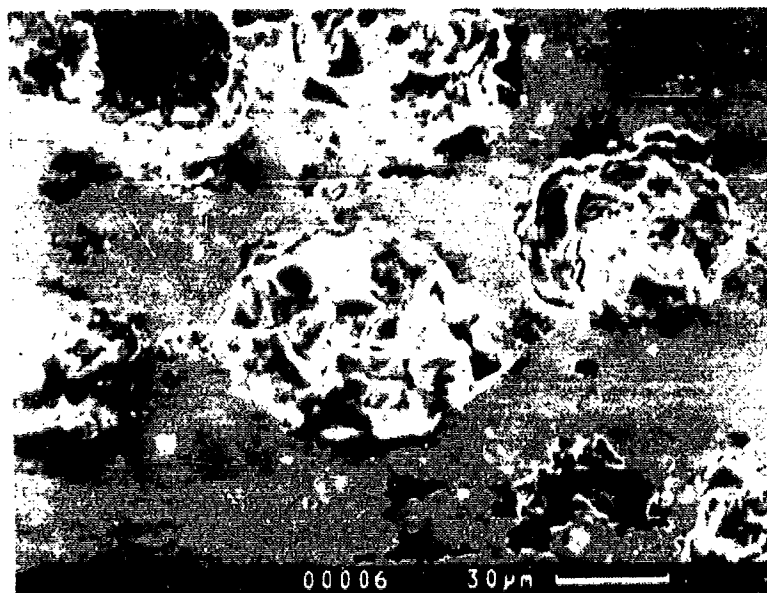
Figure 11. Corrosion Pits in M50 Bearing Steel. Notice typical "mudcracking" appearance.

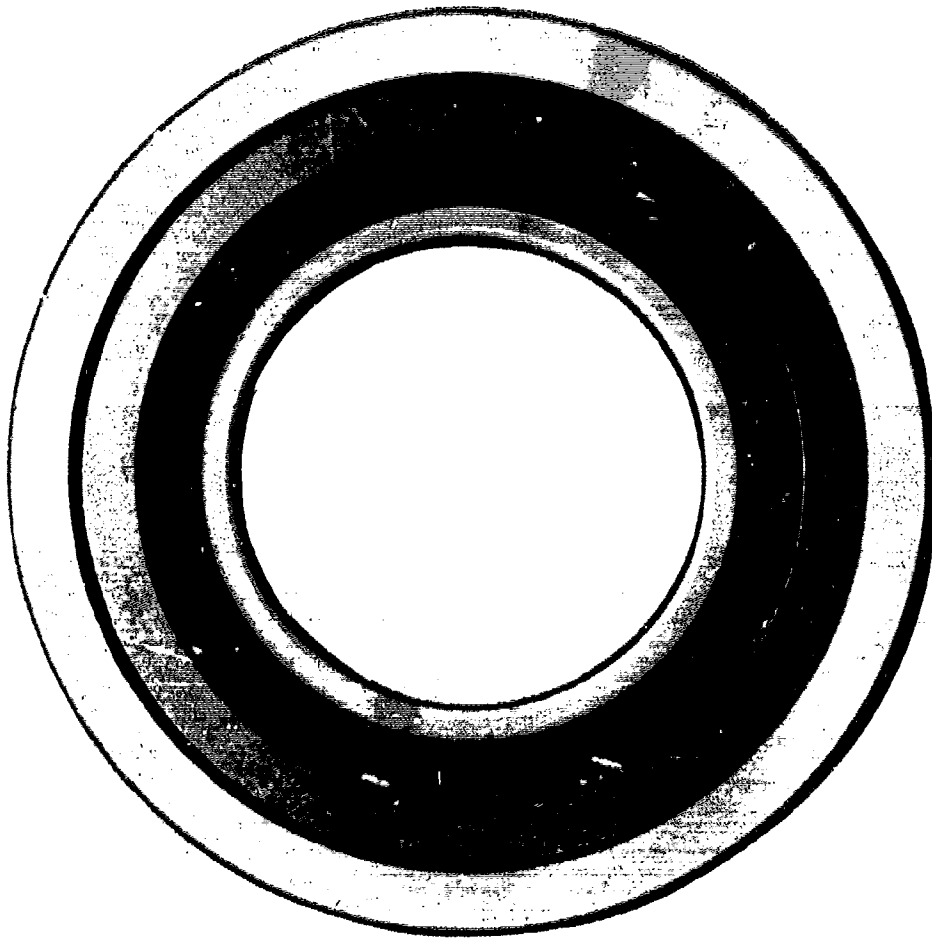
Figure 50. Bearing No. 6 After Corrosion Test.

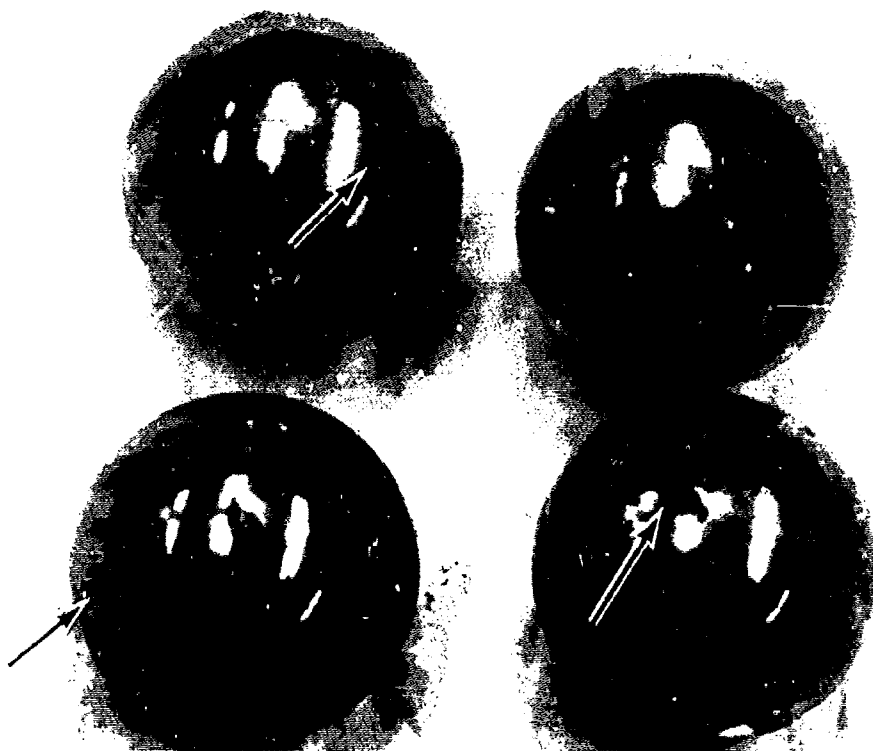
Figure 53. Balls from Bearing No. 6 After Corrosion Test.

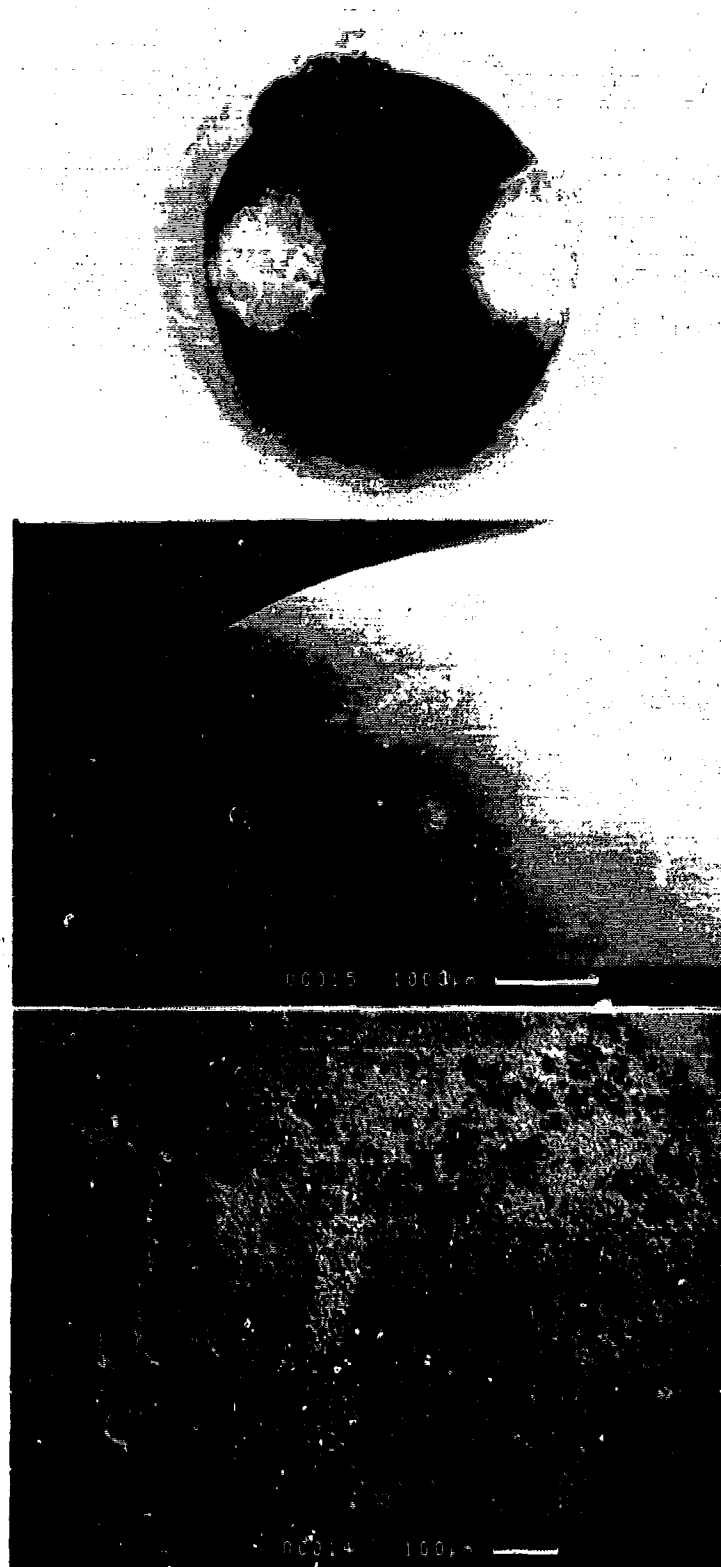
Figure 54. Typical Corrosion on Ta⁺ Implanted M50 Ball Bearing No. 6.

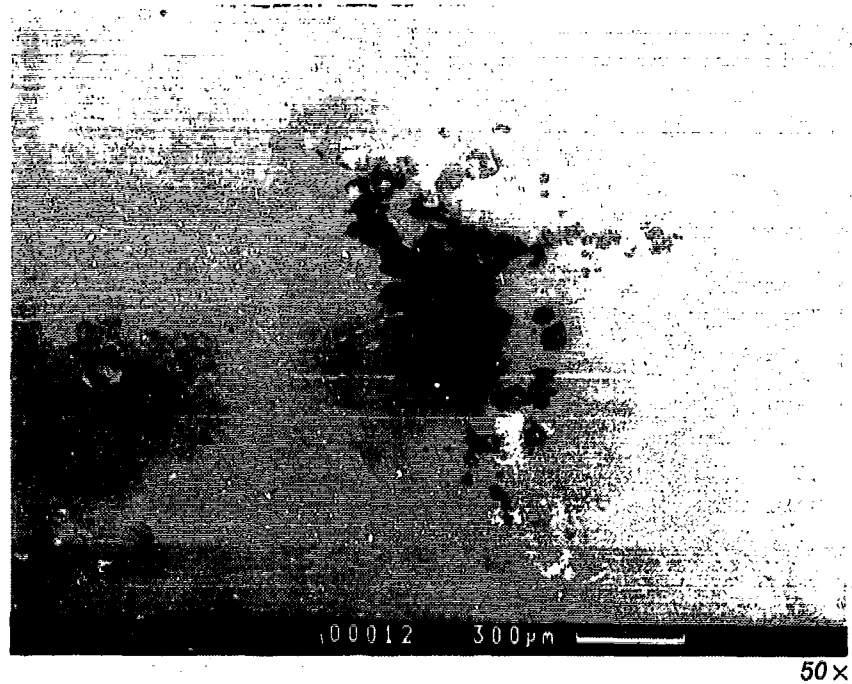
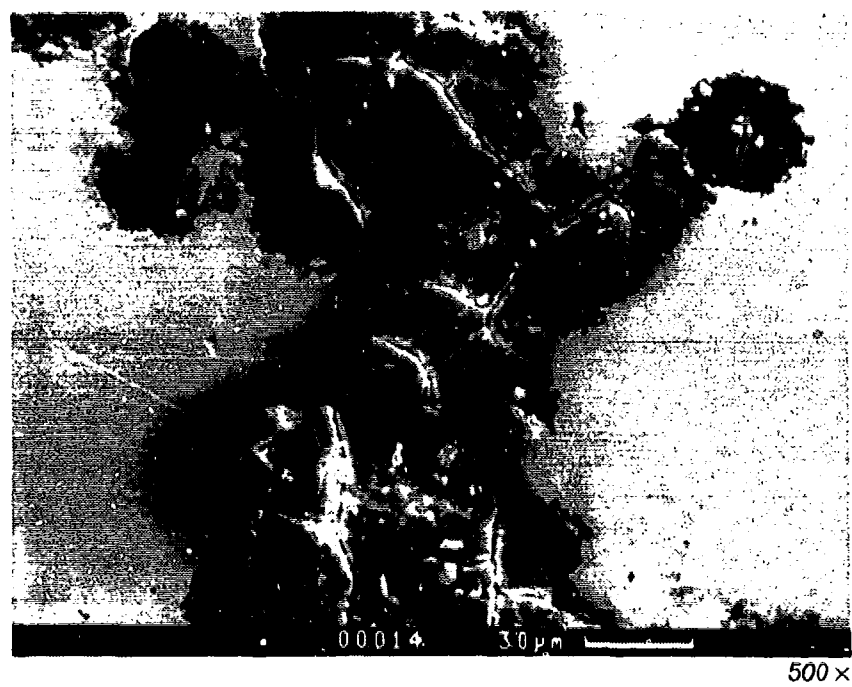
Figure 55. Corrosion Pitting on Ta^+ Implanted M50 Ball (Bearing No. 9 After 347 Hours). Note typical "mudcracking" in lower photo.

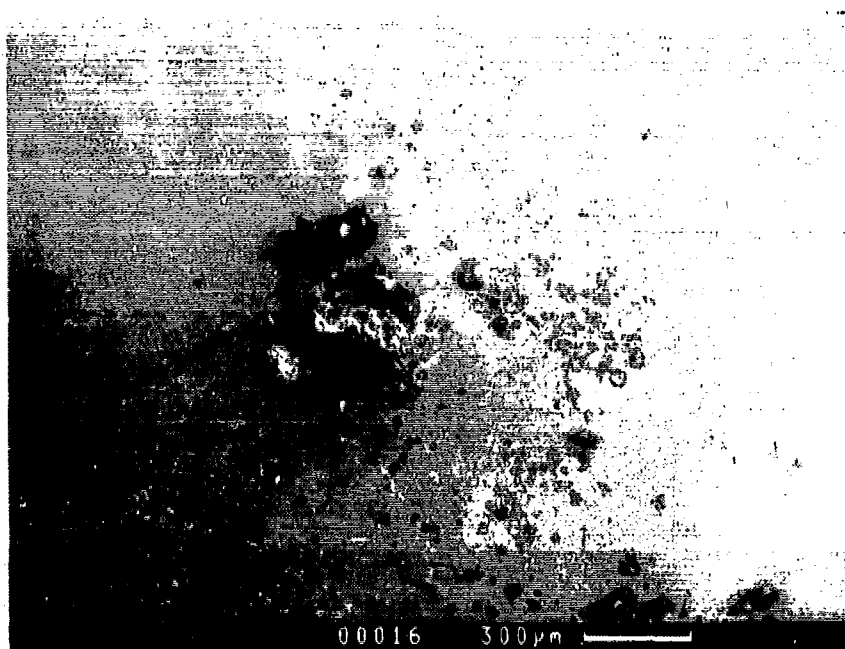
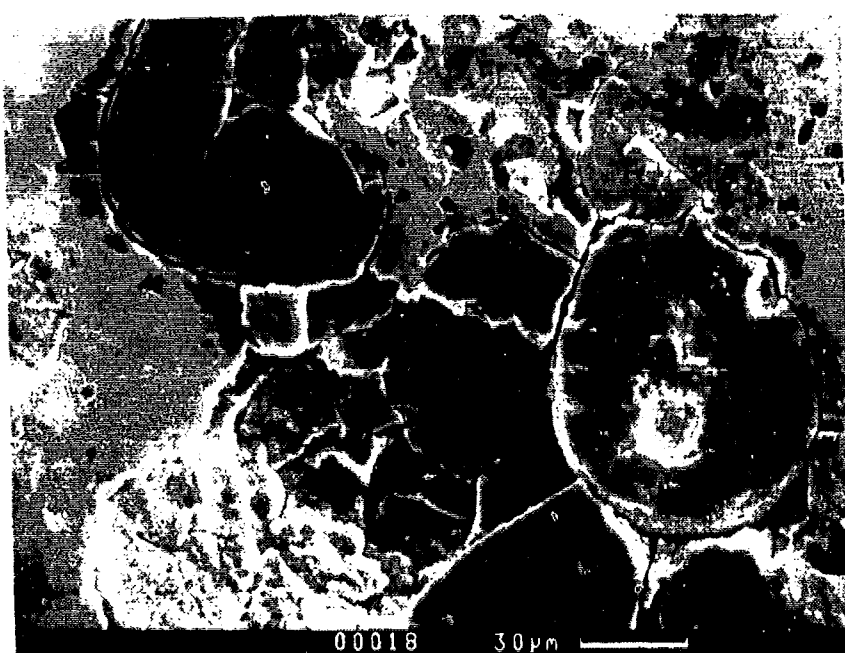
Figure 56. Typical Corrosion Pitting on Ta⁺ Implanted Ball (Bearing No. 9 After 347 Hours).

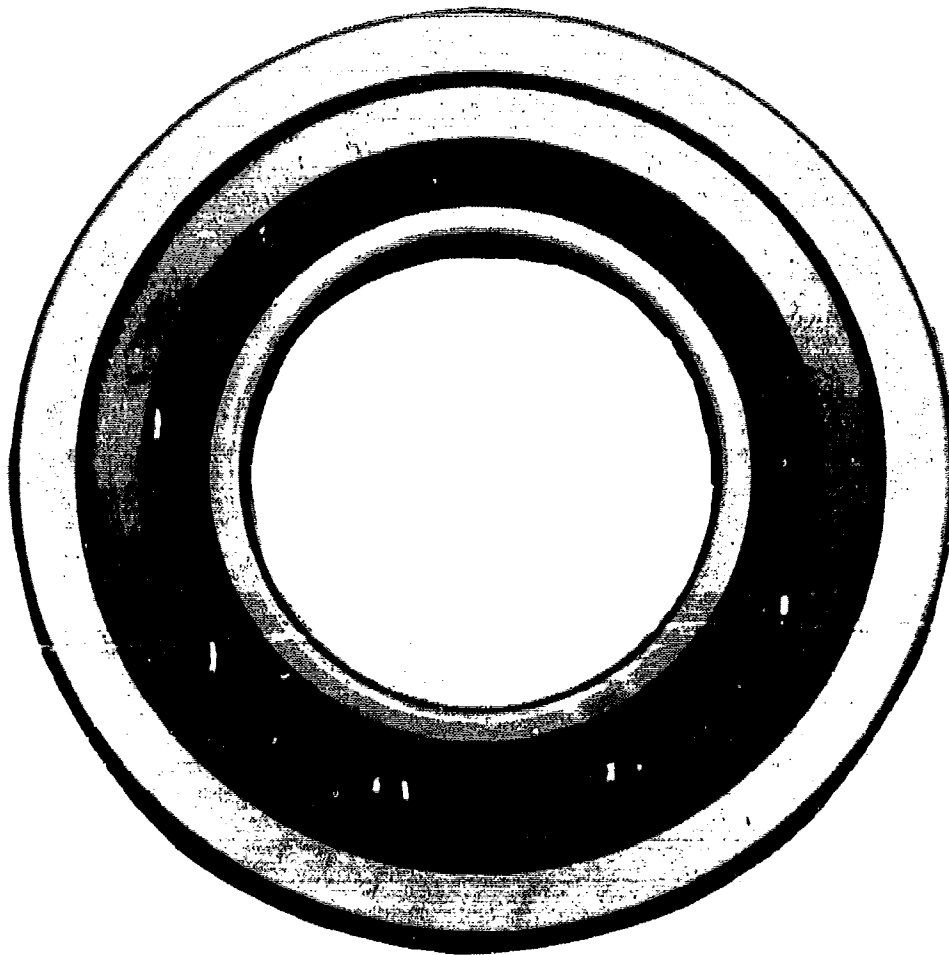
Figure 57. Bearing No. 12 After Corrosion Test.

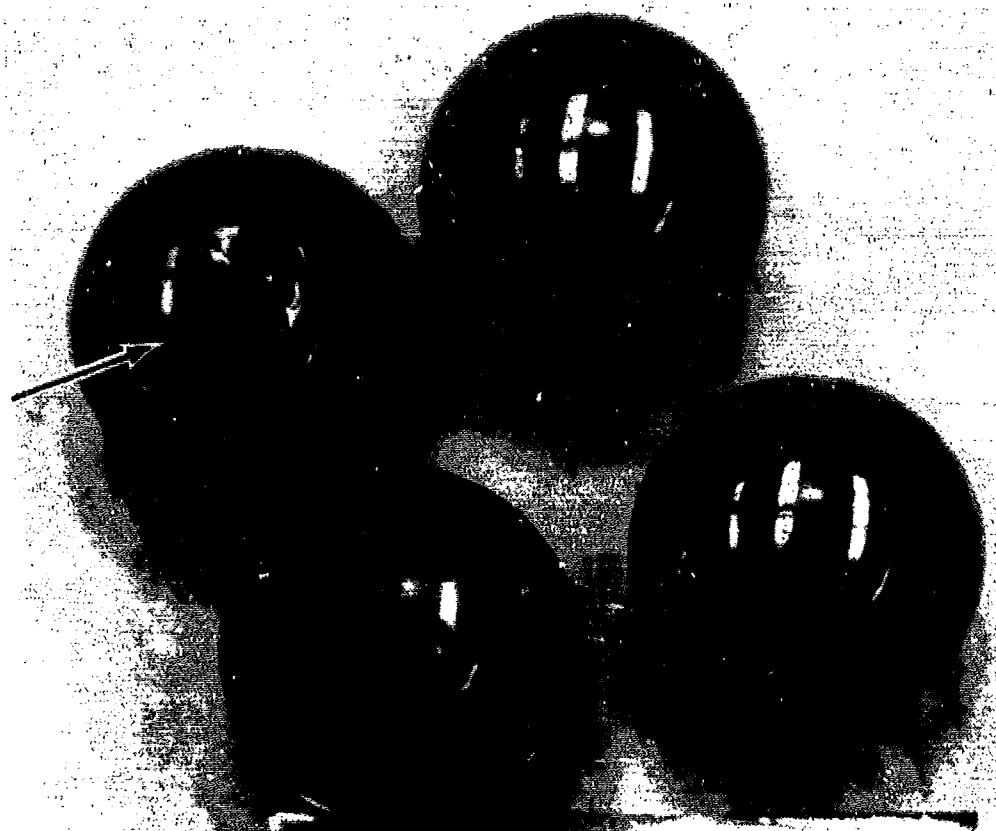
In the test bearings, the Ta⁺ implanted balls were not able to endure the minor scuffing and skidding action inherent in any full-scale test (and even more so in real-life engine operation). In fact, most of the corrosion pitting was observed in areas of the ball that also showed evidence of scuffing or skidding. It must be remembered that the test bearings were prerun (as were all test bearings) in contaminated oil (2.5 ppm of 20- μm Al₂O₃) for 15 minutes. Consequently, the bearing results are in good agreement with the ball-rod test data.

Figure 62. Balls from Bearing No. 12 After Corrosion Test.

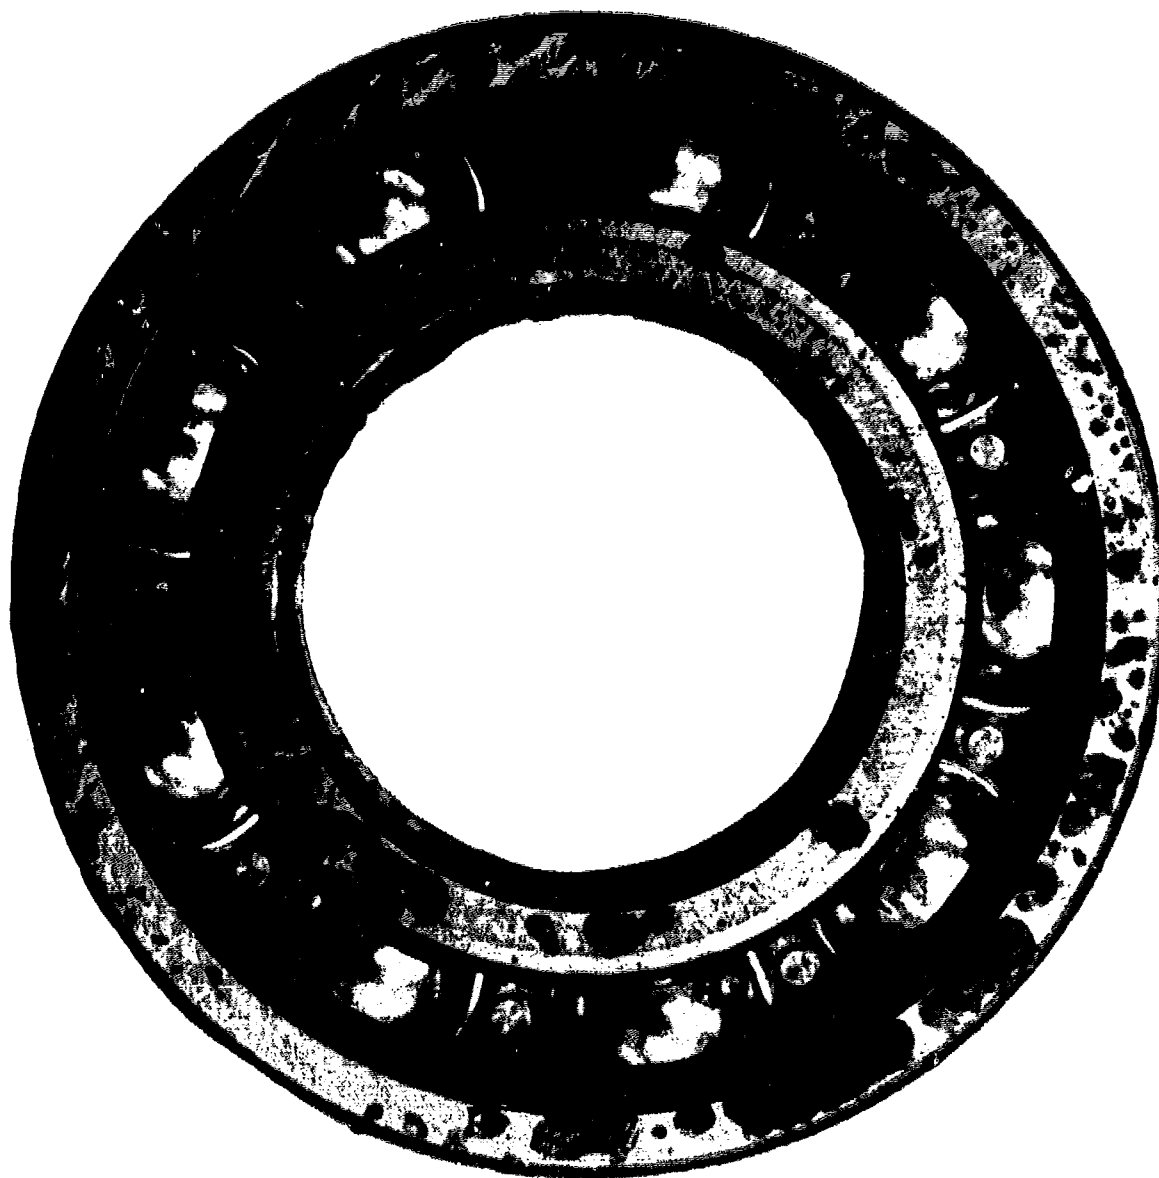
Figure 64. New, Uncoated Control Bearing After Corrosion Test.

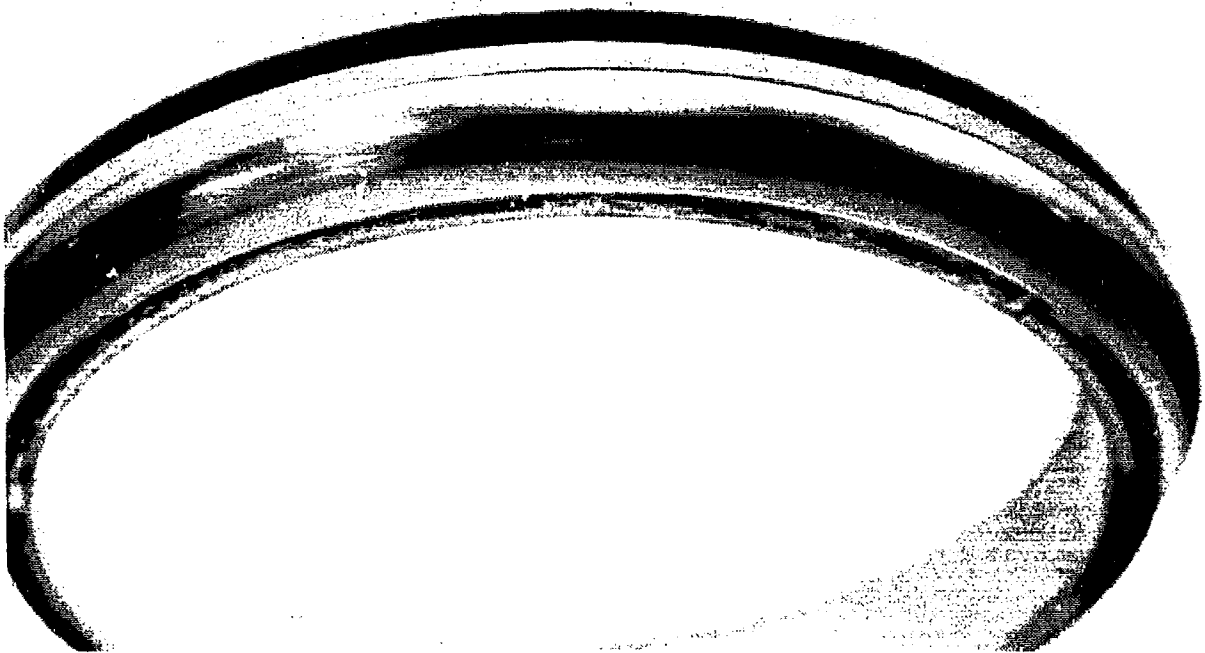
Figure 75. Loaded Inner Ring (TDC Coated) of 133-mm Bore Bearing After Component Test.
